# Sediment modeling workshop

“Erosion and sedimentation processes  
in the Tijuana River Watershed”

Case study: Los Laureles Canyon

Doctoral Thesis in Environmental Geosciences

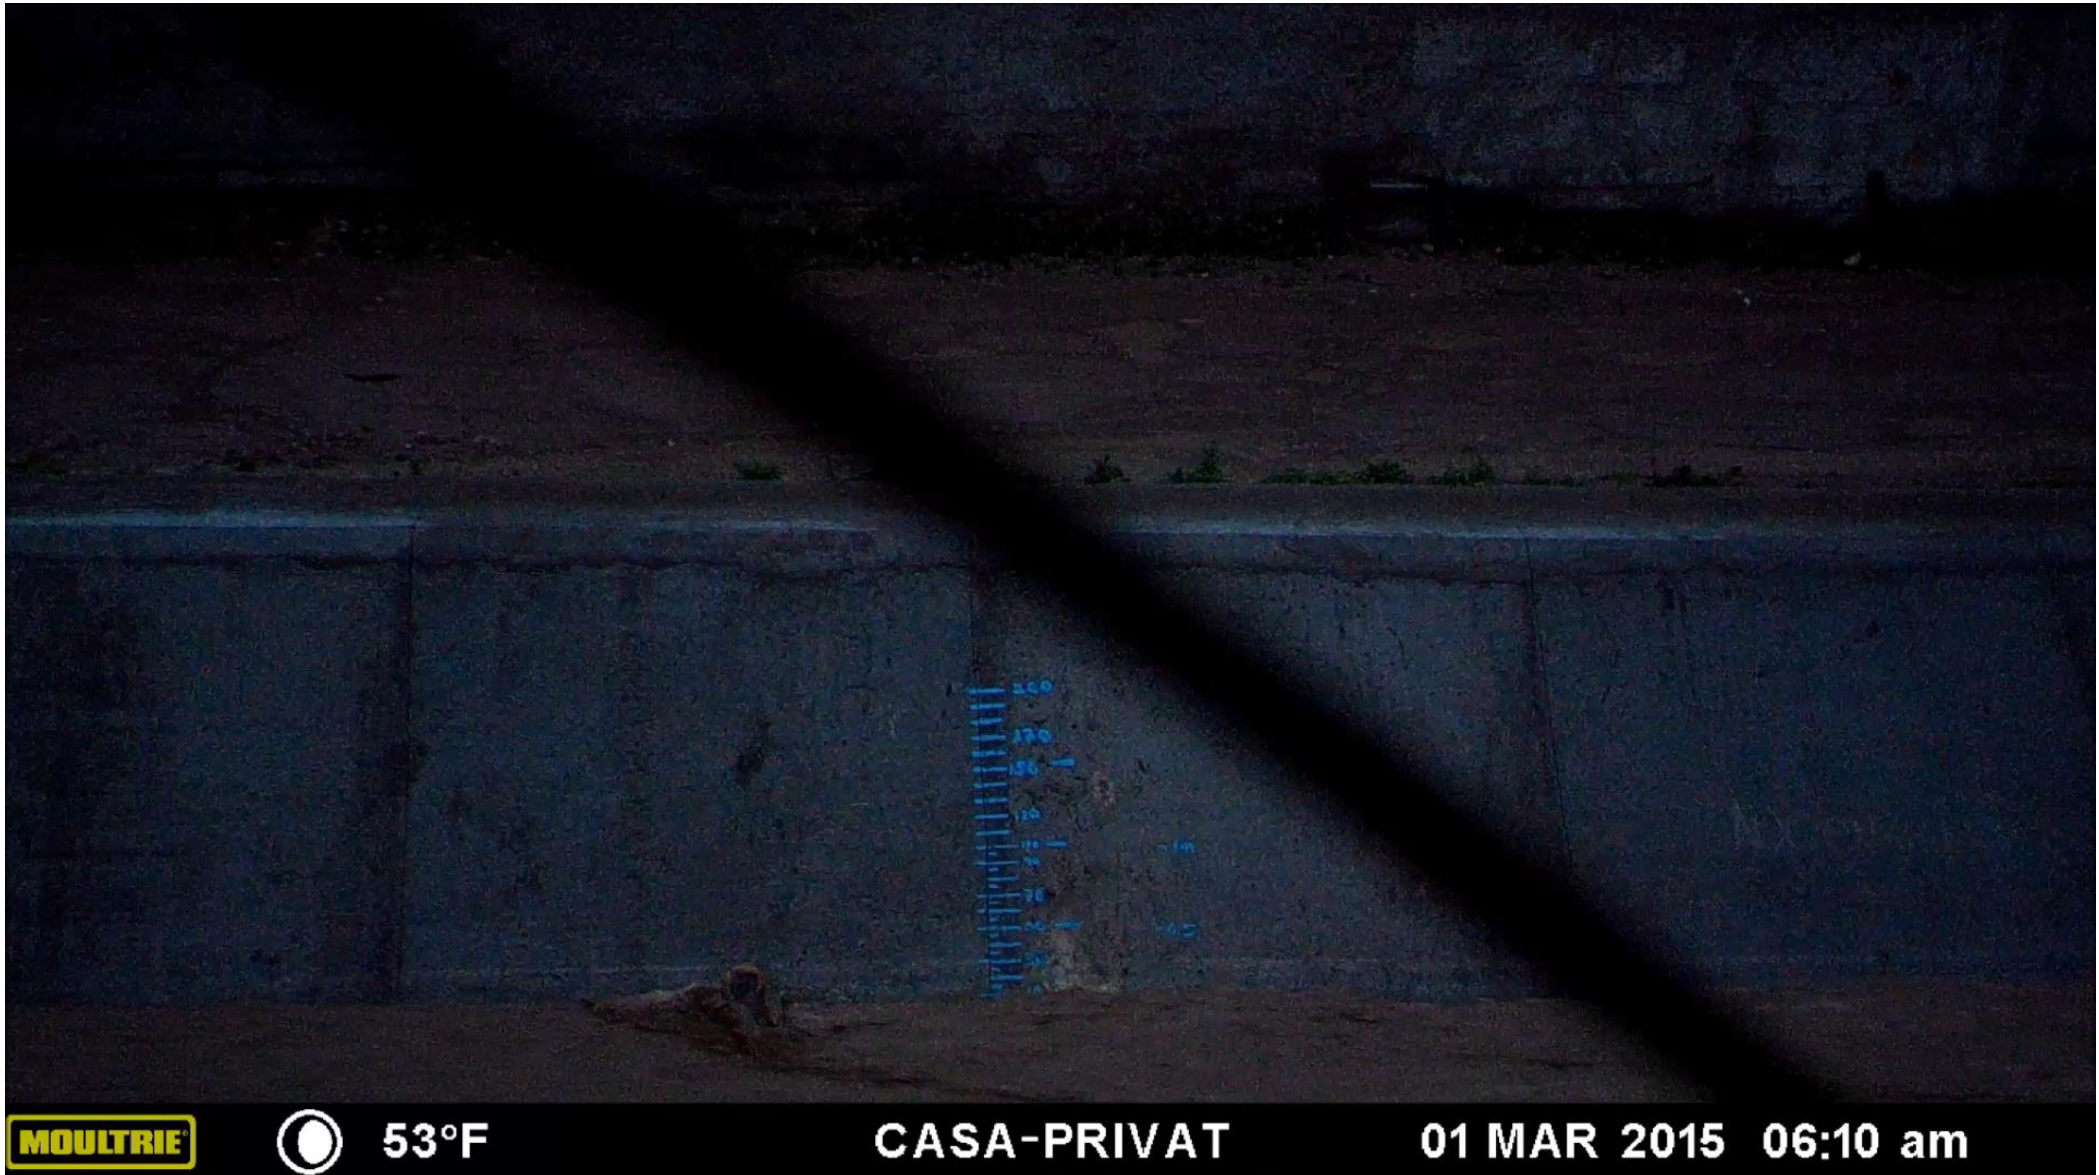
# Discharge (cameras)

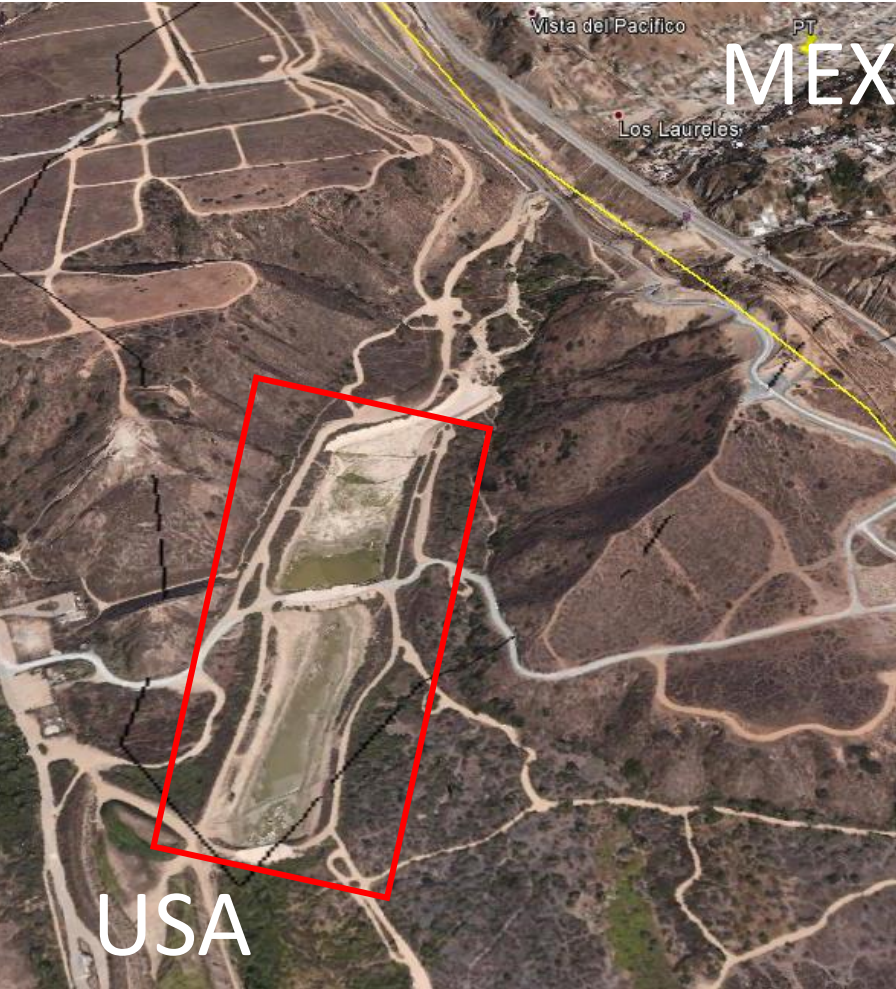
# Validation (Sed traps at the outlet)

**Table 2. Observed and modelled annual sediment yield at the outlet of Los Laureles Canyon from AnnAGNPS, under current conditions.**

Water year	AnnAGNPS, sum of input to channels	Observed in trap at outlet (US side)	Relative error (%)
2006	7193	31920	23
2007	37337	31920	116
2008	21313	51072	42
2009	120178	76608	156
2010	57173	70224	82

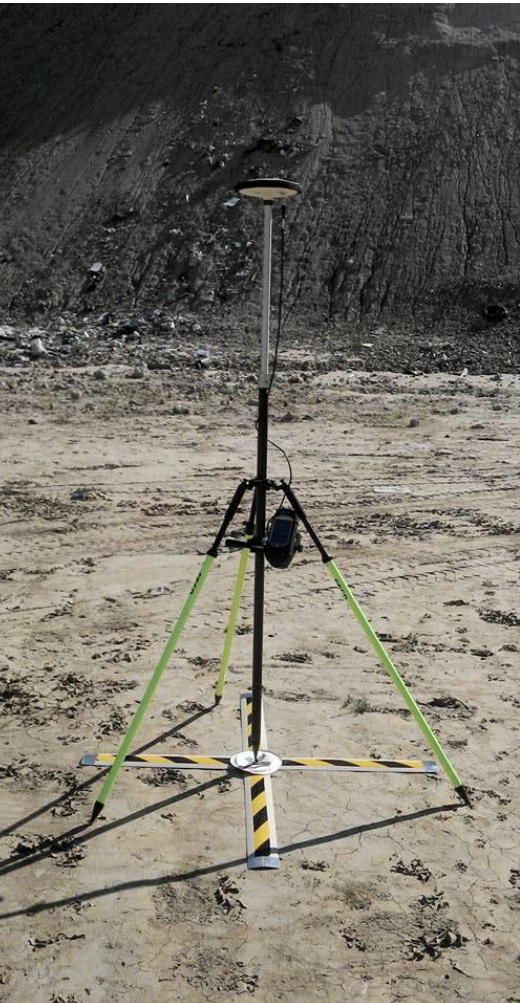
Ground Control Points dGPS

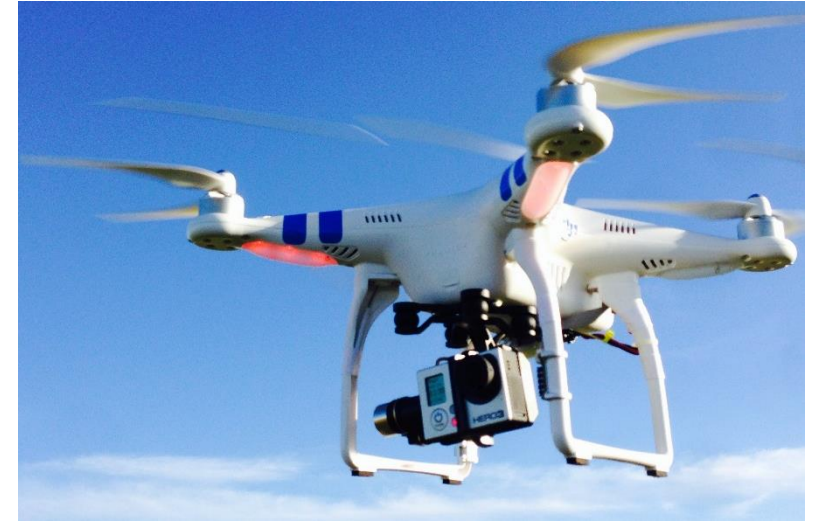
Drone (DJI phantom2)

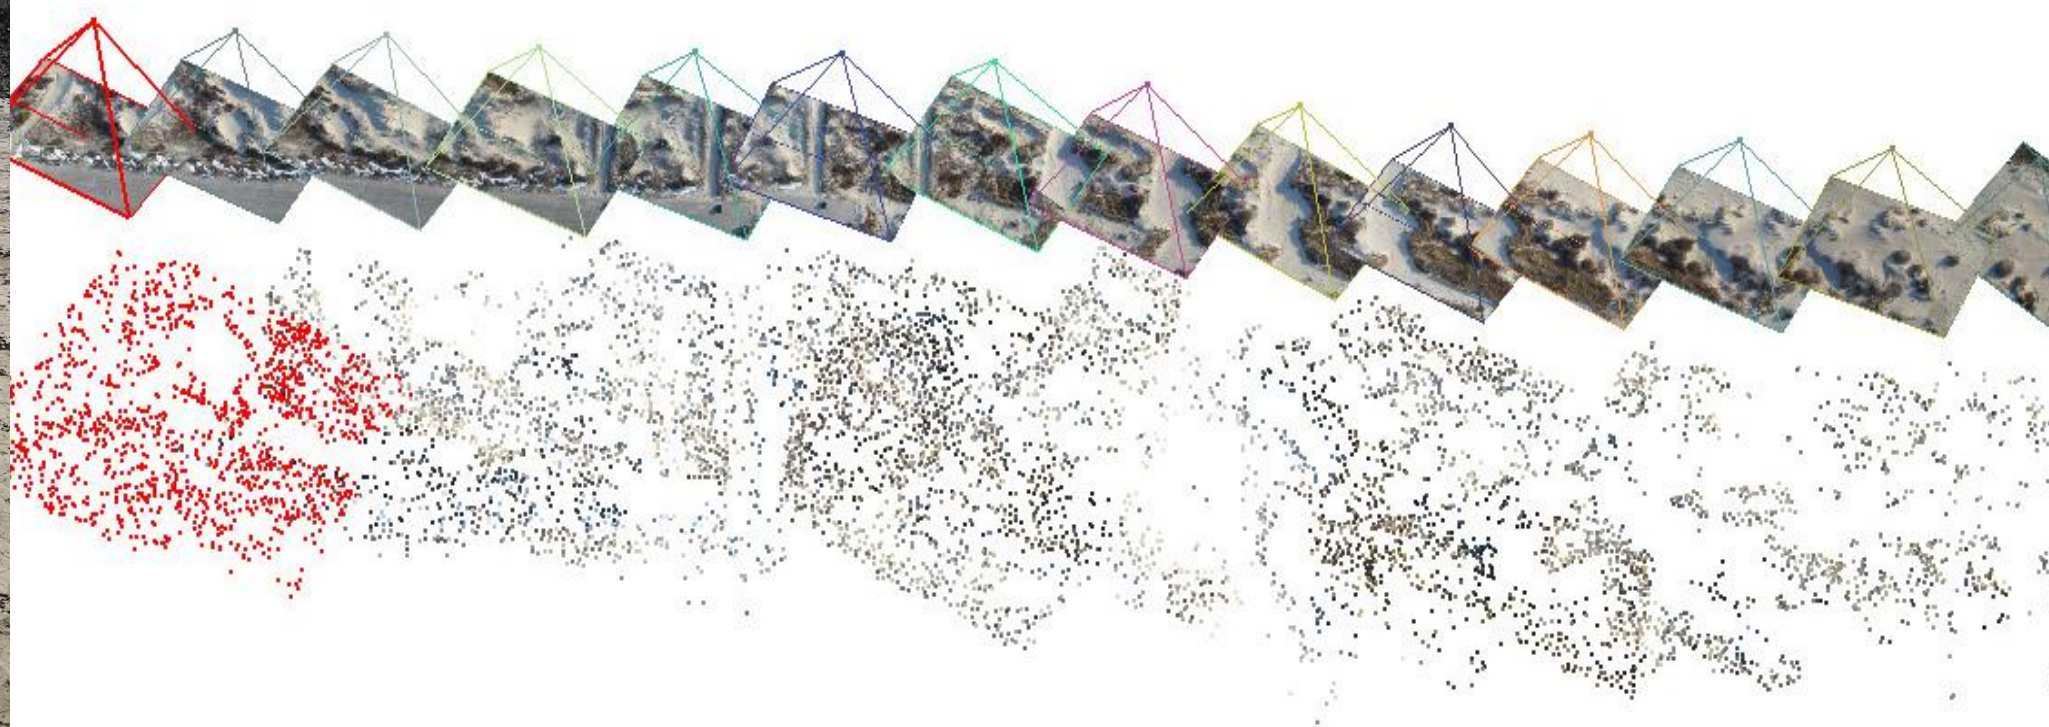
Point cloud (AGIsoft)

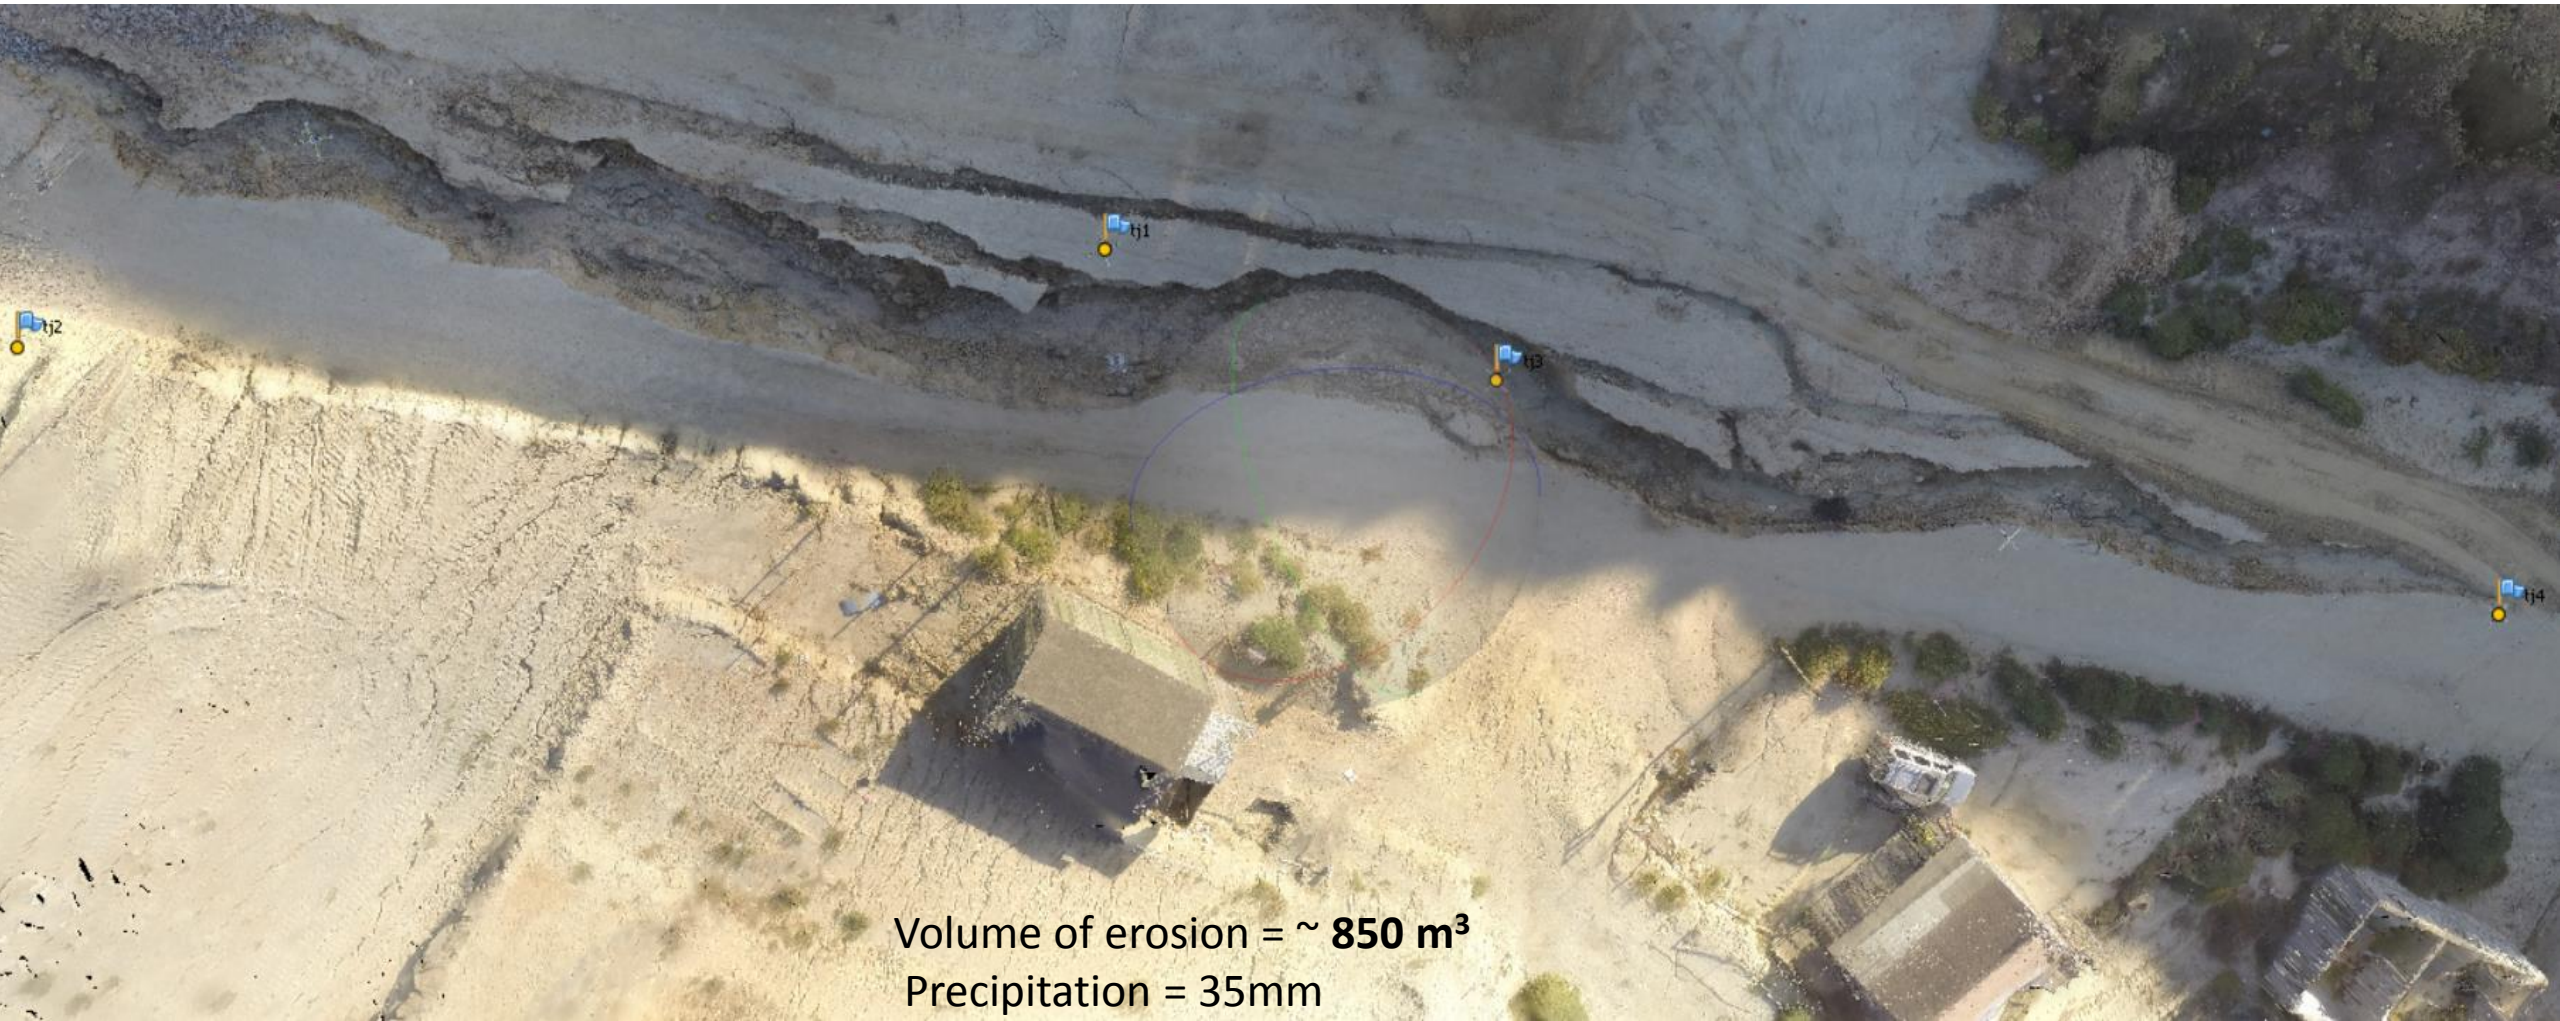
# 3D Photo-reconstruction

(September 16, 2015)

Before

After

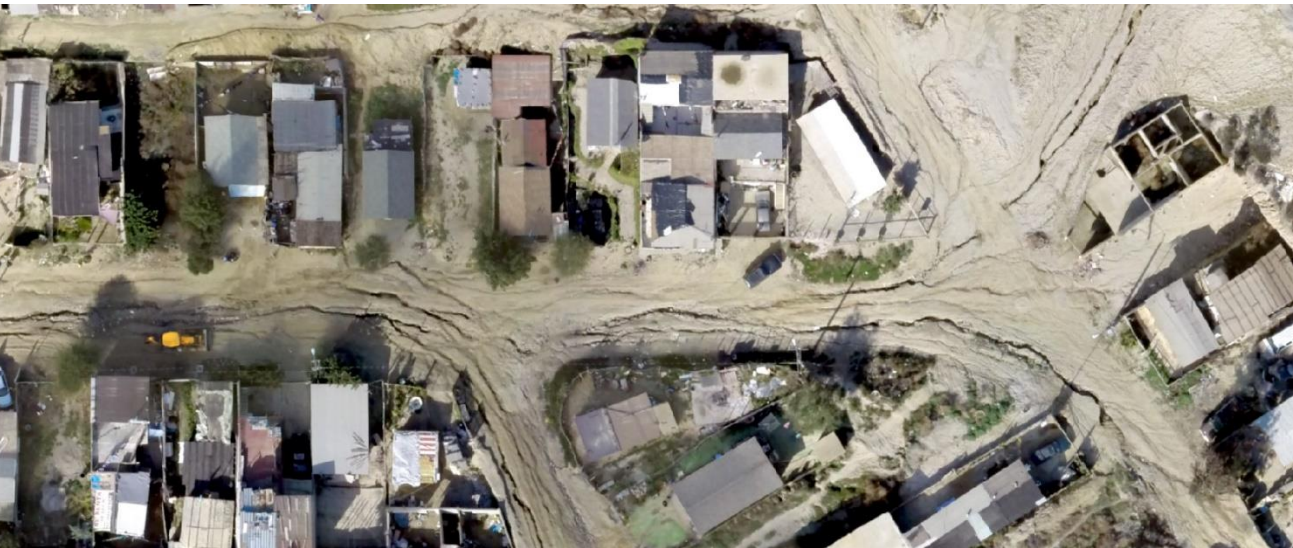
San Bernardo

# Gully inventory based on drone surveys
